United States Department of the Interior  
National Park Service**National Register of Historic Places Registration Form**

**1. Name of Property**Historic name: RotherwoodOther names/site number: DHR ID 087-0045Name of related multiple property listing: N/A

**2. Location**Street & number: 15410 Southampton ParkwayCity or town: Capron State: VA County: SouthamptonNot For Publication: ☐ N/A Vicinity: ☐ N/A**3. State/Federal Agency Certification**

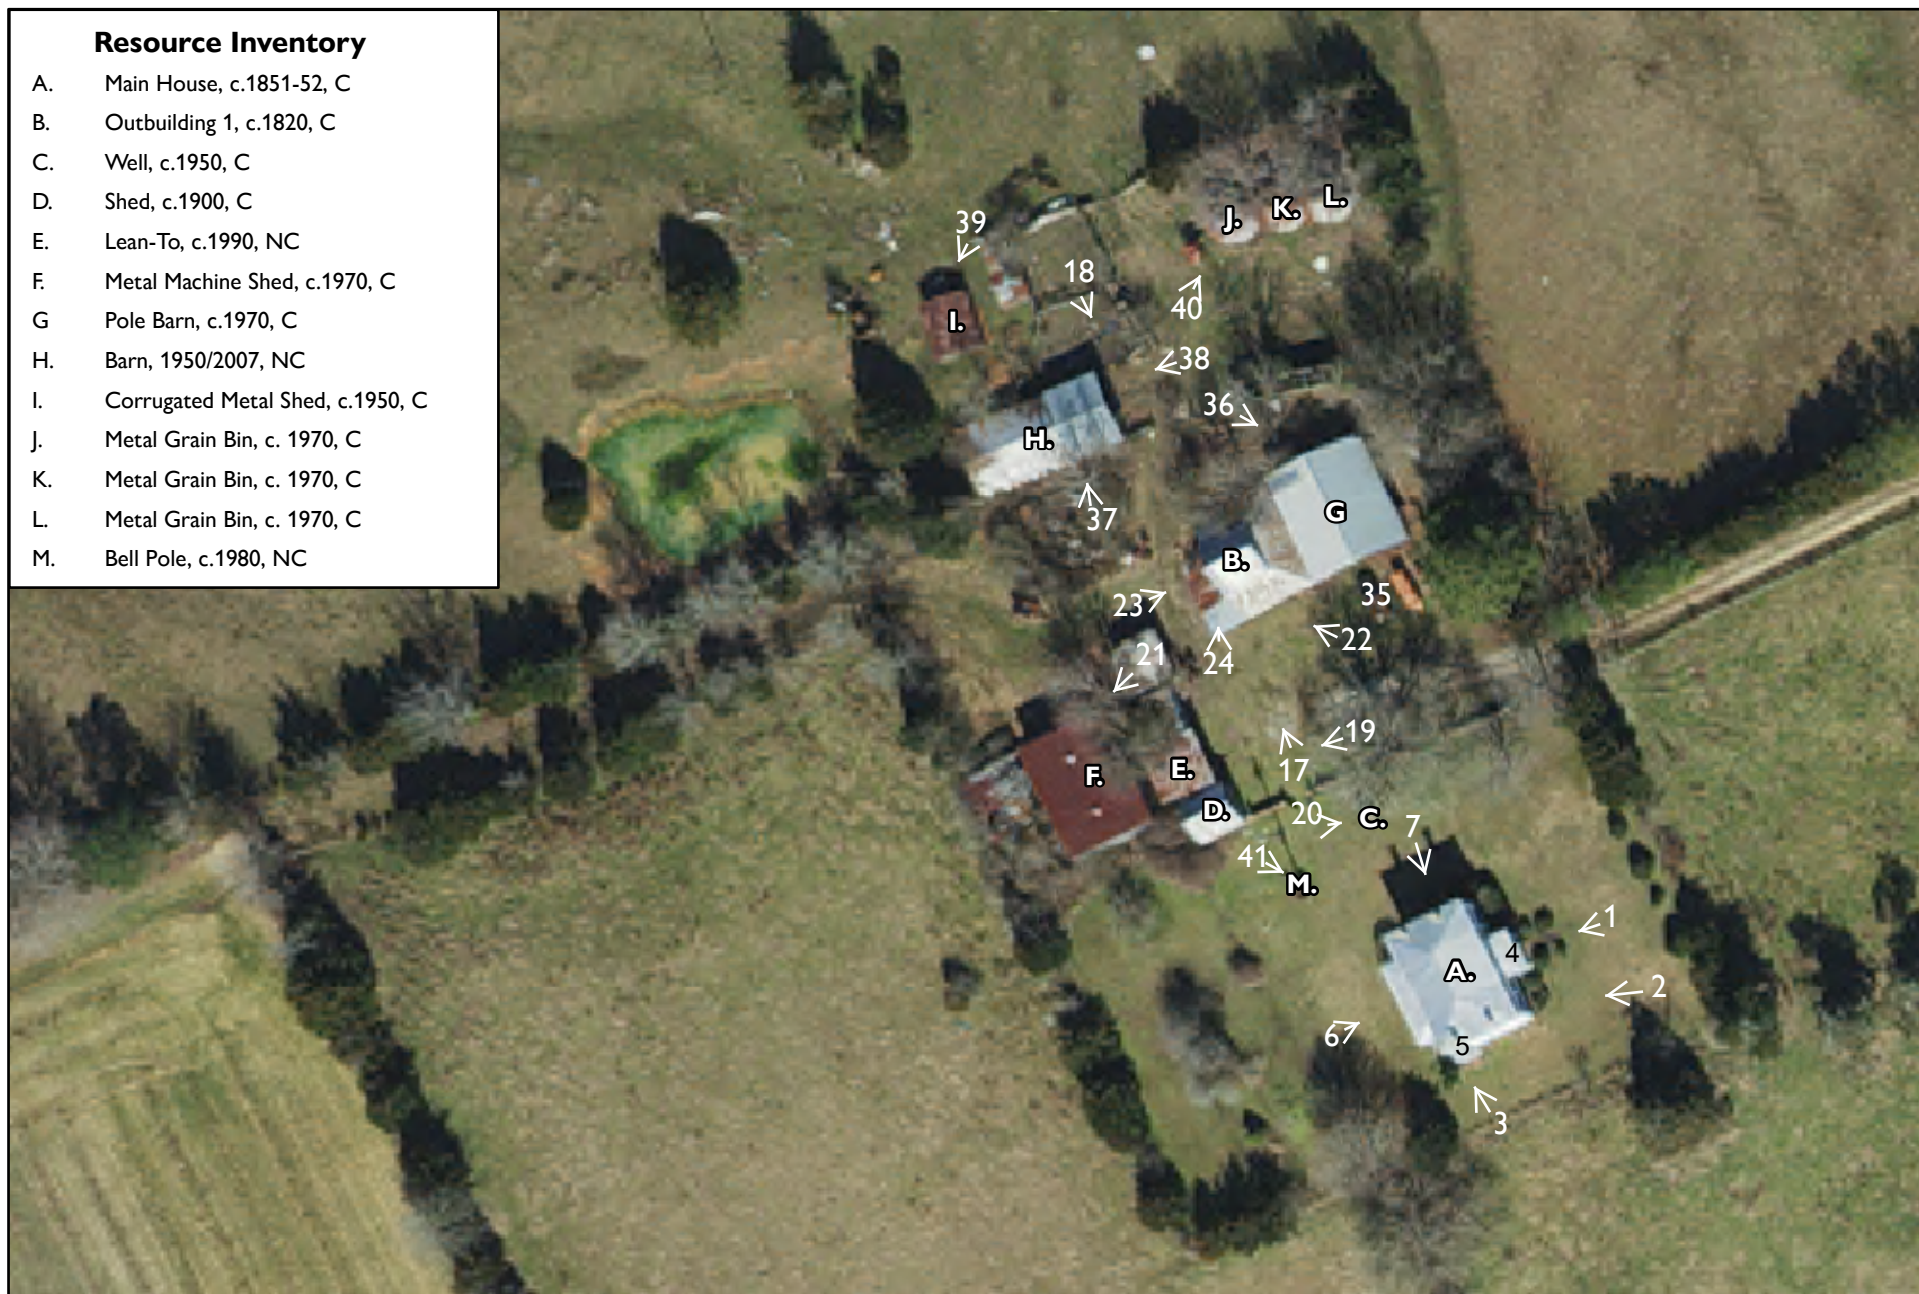
## Sketch Map/Photo Key (Architectural Resources)

- A. Main House, c.1851-52, C
- B. Outbuilding 1, c.1820, C
- C. Well, c.1950, C
- D. Shed, c.1900, C
- E. Lean-To, c.1990, NC
- F. Metal Machine Shed, c.1970, C
- G. Pole Barn, c.1970, C
- H. Barn, 1950/2007, NC
- I. Corrugated Metal Shed, c.1950, C
- J. Metal Grain Bin, c. 1970, C
- K. Metal Grain Bin, c. 1970, C
- L. Metal Grain Bin, c. 1970, C
- M. Bell Pole, c.1980, NC
